Name of Dam: Piedmont Geriatric Hospital Dam

Location: Nottoway County, Commonwealth of Virginia

Inventory Number: VA 13520

PHASE I INSPECTION REPORT NATIONAL DAM SAFETY PROGRAM

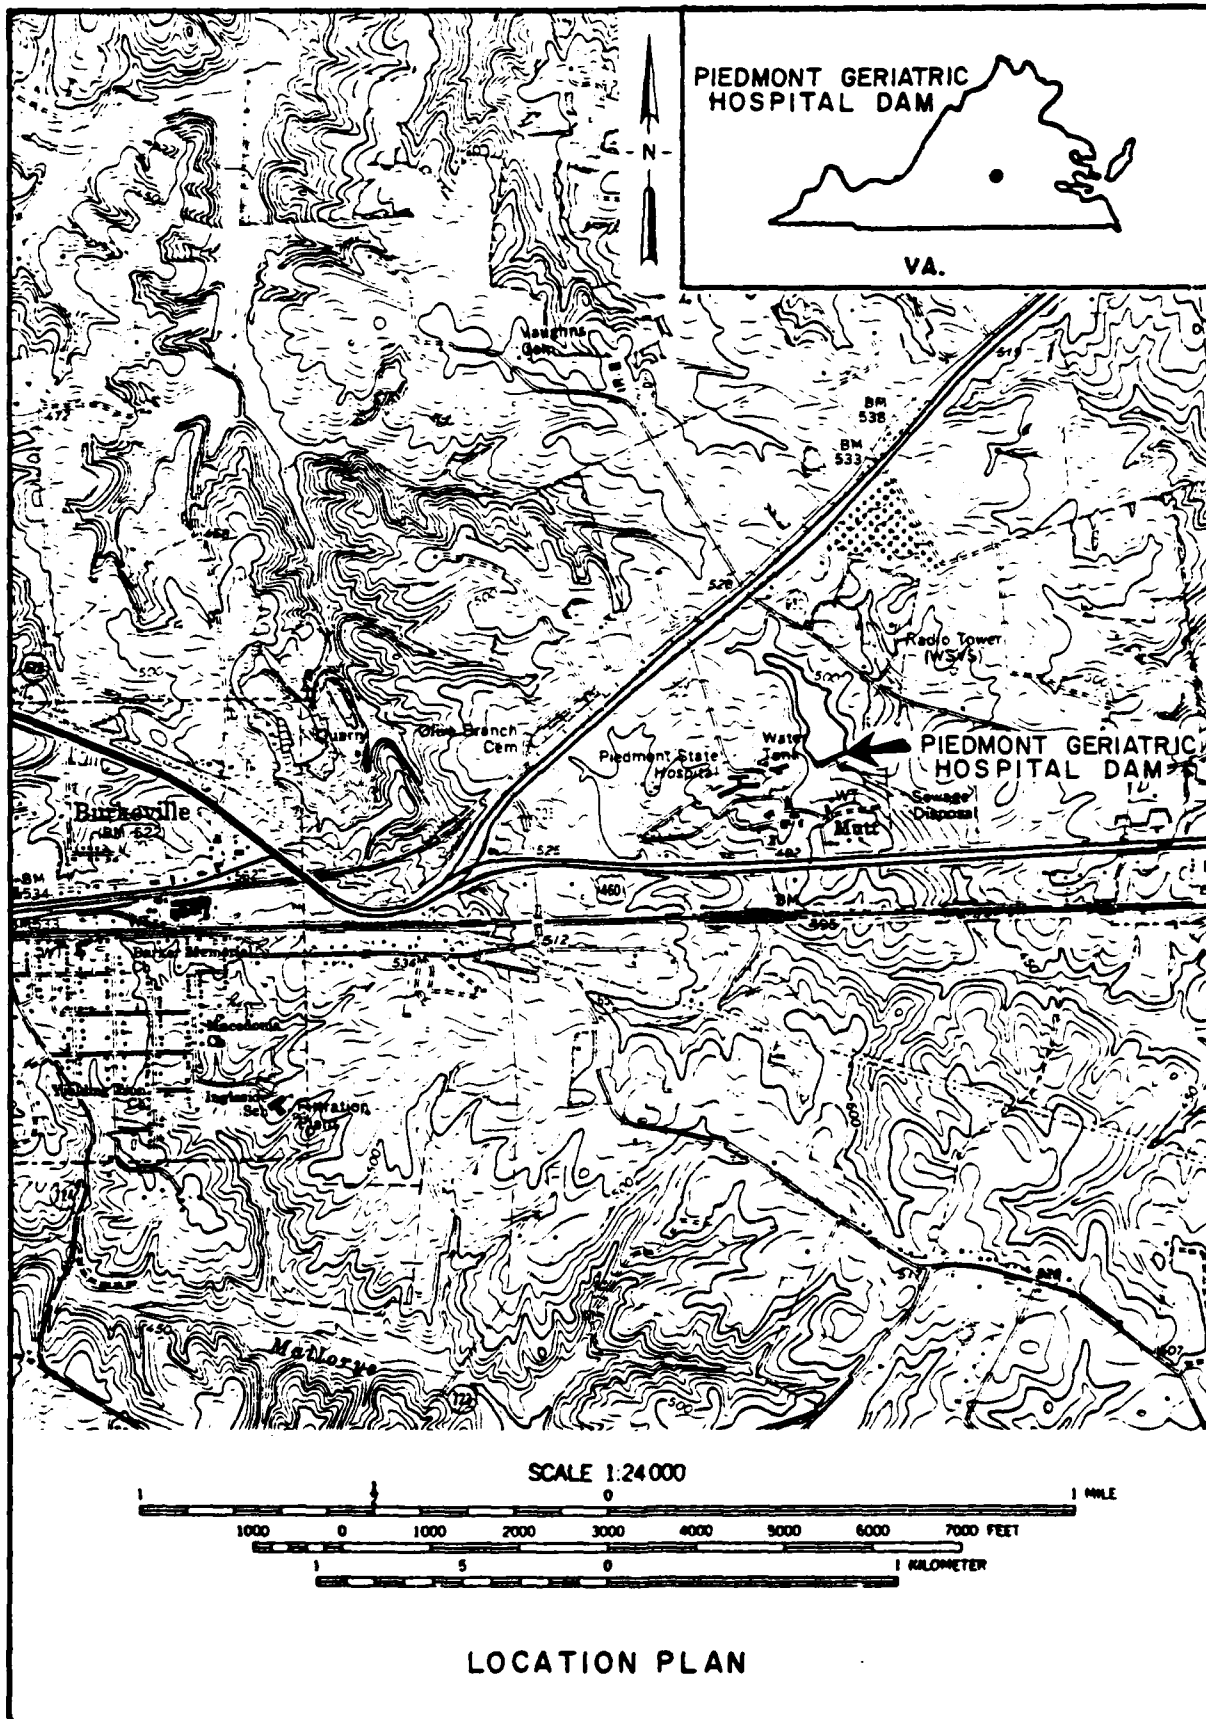
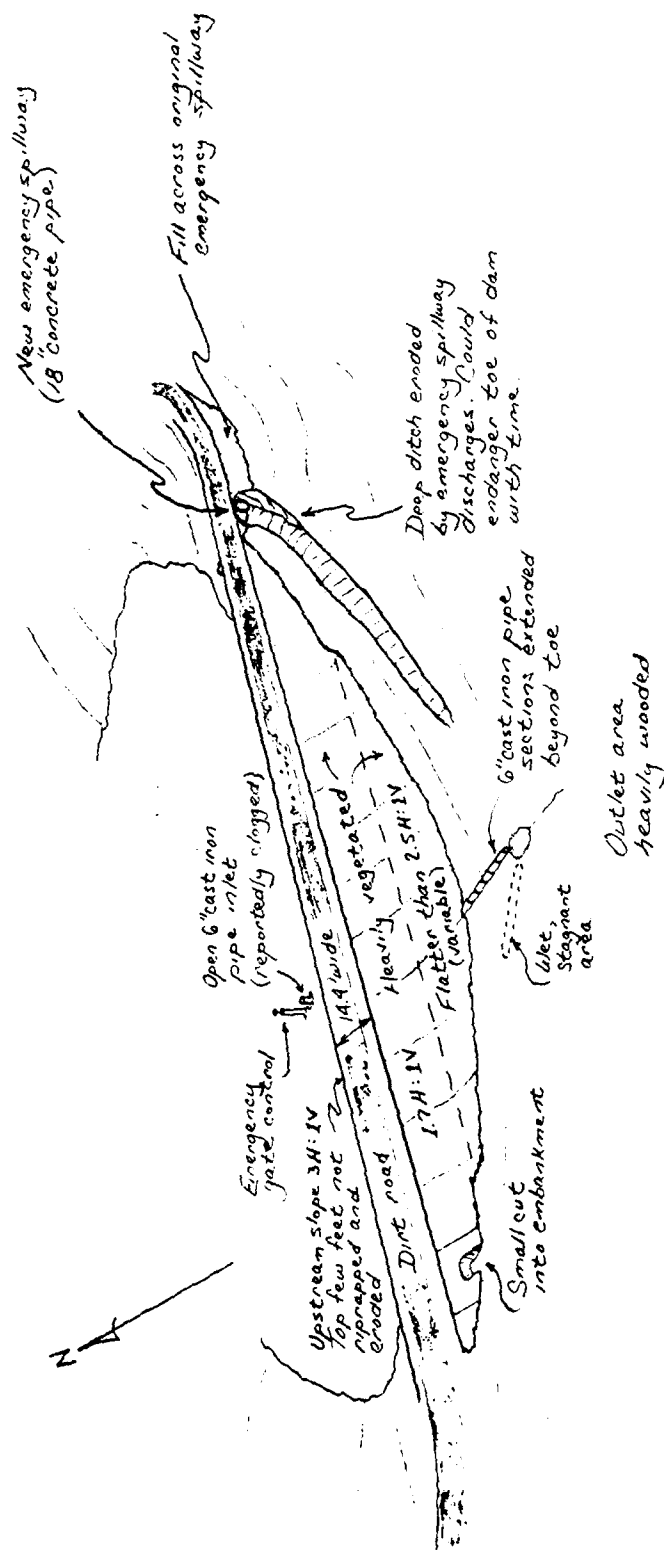
FIELD SKETCH PIEDMONT GERIATRIC HOSPITAL DAM, VIRGINIA

The deficiencies noted during the field inspection are described in the following paragraphs. The complete field compiled descriptions are included in Appendix III. A field sketch depicting existing conditions is included as Plate 1 in Appendix I.

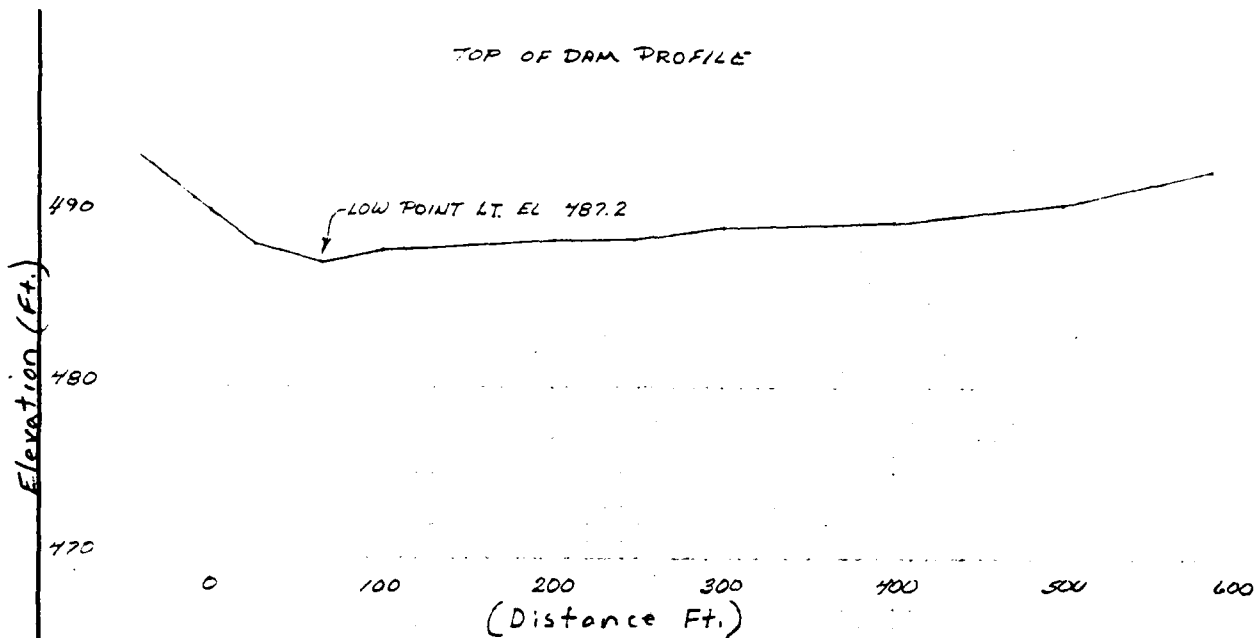
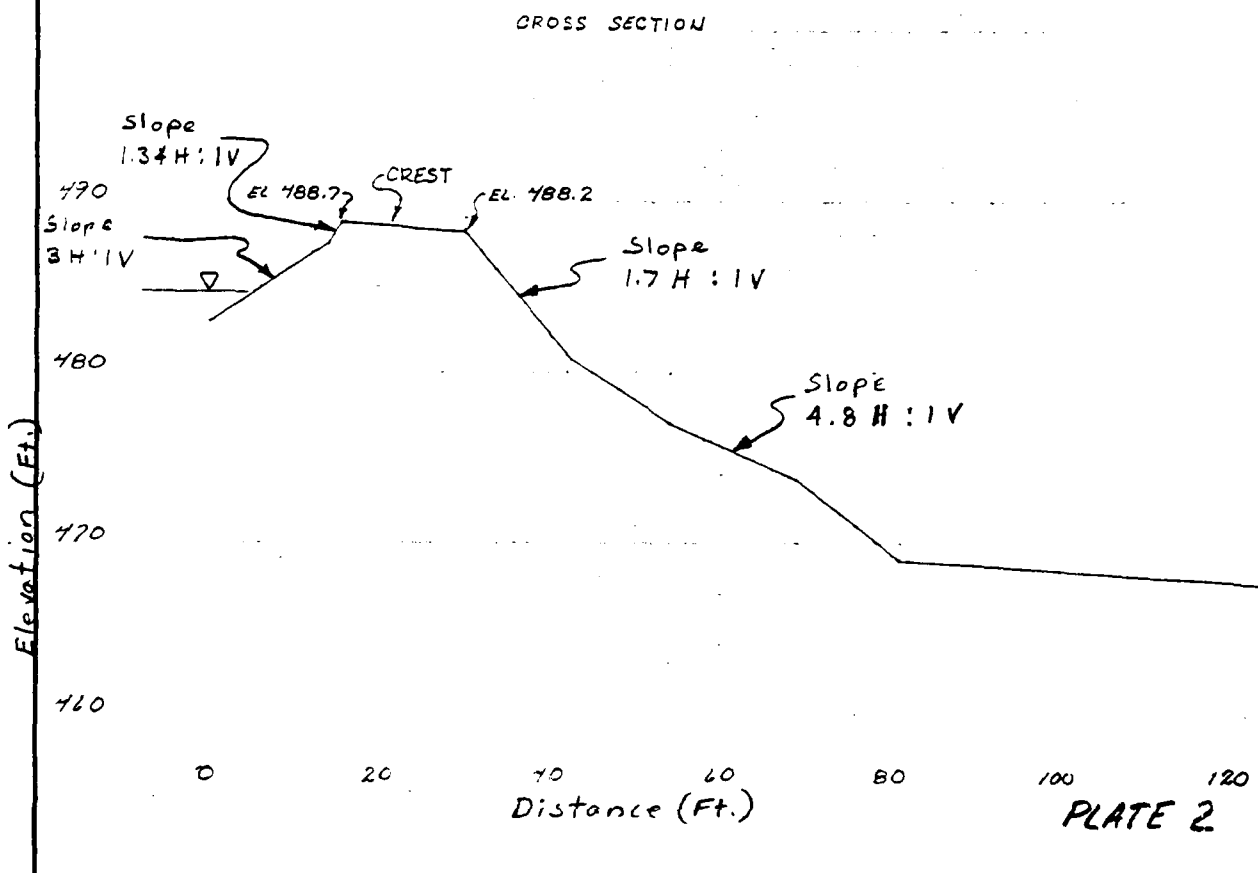
PLATE 2

Plate 2: Top of Dam Profile and Typical Dam Cross Section
